Dealing with bats: monitoring of the mitigation process and the effectiveness

Abstract. The article draws the attention to the significance of monitoring for effectiveness of mitigating means used in case of natural habitats fragmentation caused by transport infrastructure. A problem was illustrated on the example of activities taken in Holland in connection with the construction of road N296 and N297, which threatened, among others, populations of 3 species of bats.

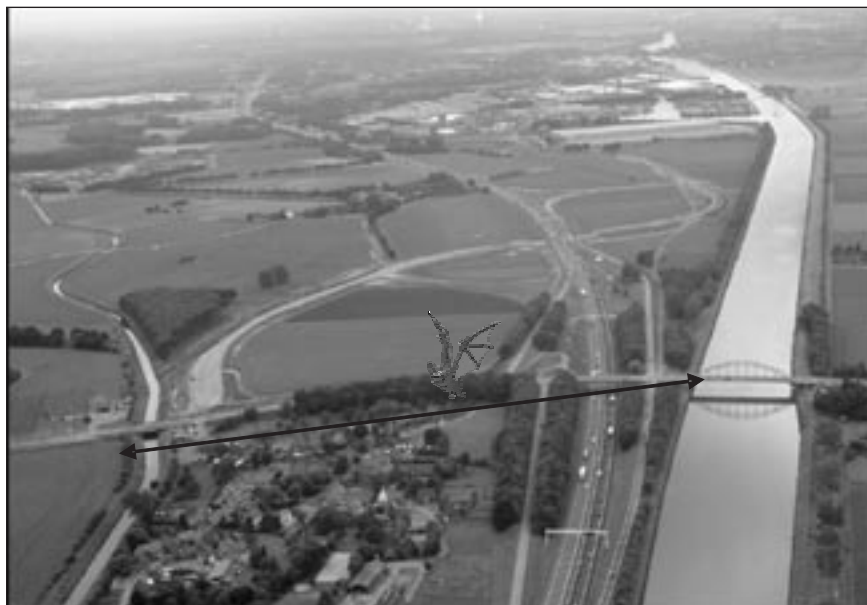
Fig. 3. Impression of the habitat and the flyway of bats near the planned N296

The first step in the process of protection measures was a field research. This field research showed that in case of the N296 and the N297 the Daubenton's bat (*Myotis daubentoni*), the Common pipistrelle (*Pipistrellus pipistrellus*) and the Serotine (*Eptesicus serotinus*) use the habitat within the sphere of influence of these (new) roads (Figs. 2 and 3).

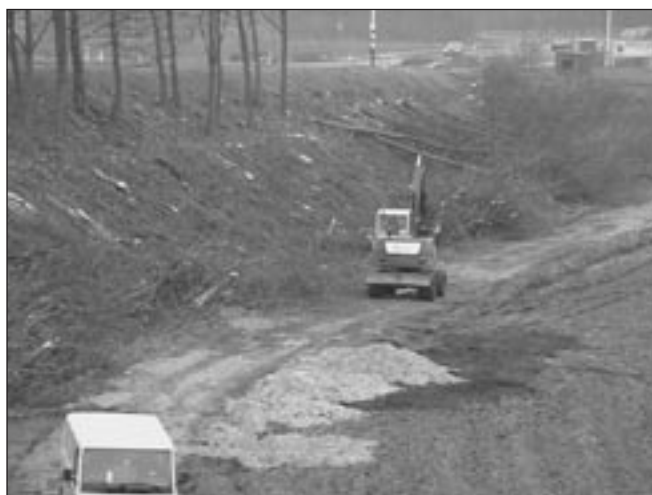
Fig. 4. Cutting of trees

Because of the construction of both roads, trees had to be cut, through which forage area of bats disappeared and flyways of bats were interrupted (Fig. 4). In the new situation flyways are being restored with the planting of trees. On the roads that lose their function after finishing the N296, the asphalt will be removed and trees will replace the asphalt (Fig. 5). As a result the living area of the bats will increase with about 12,000 m² after the road is realized.

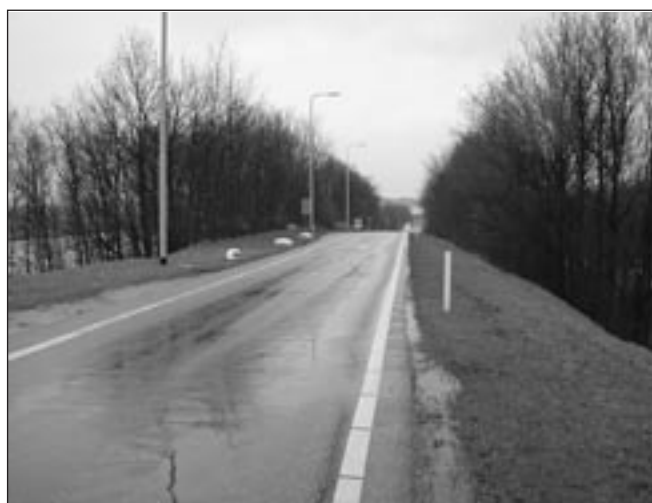
Fig. 5. Planting on roads which lose their functions

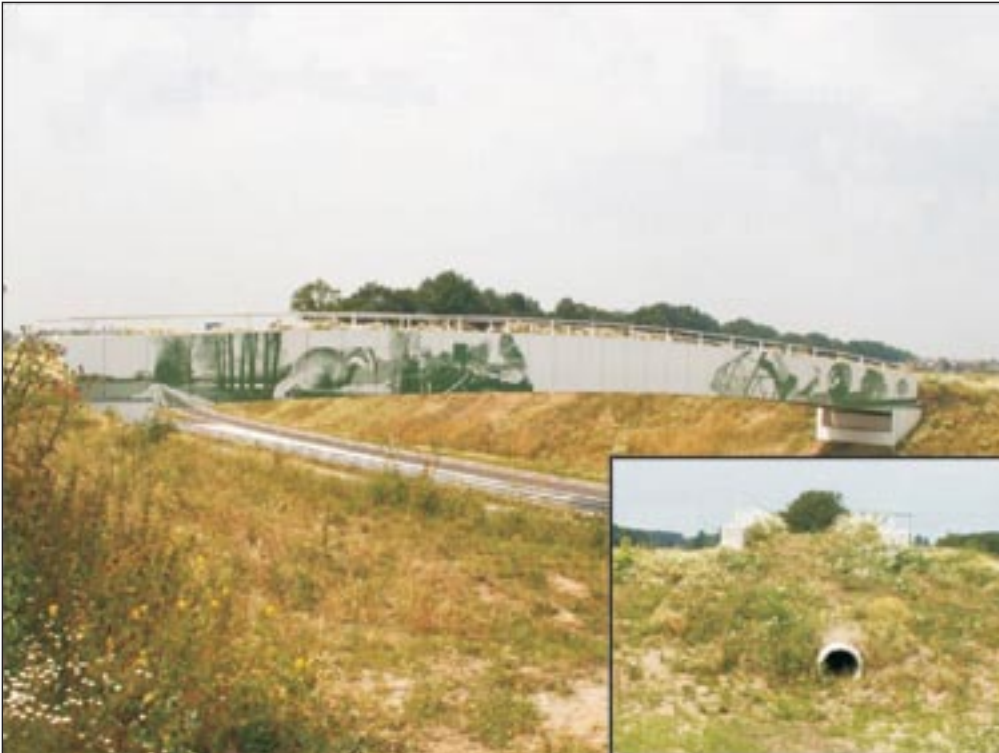
Fig. 6. The ecombiduct is a combination of a (in this case small) ecoduct and a badger tunnel

The ecombiduct is in fact a combination of a (in this case small) ecoduct and a badger tunnel (ø 40 centimetre). It's dimensions are 3 metres width and it reaches 42 metres. On this ecombiduct a 2.5 metres high hedgerow will be planted especially for the bats to restore the flyway. These hedges can also be used by other species like birds and insects as habitat and as orientation. The ecombiduct will also be useful for other wildlife, such as amphibians, reptiles and small mammals.

Also unique for this concept is the tunnel in the surface of the crossover. In this way animals have the choice to cross the road safely through the tunnel or over the ecombiduct. The tunnel can be very useful especially for animals that fear the traffic lights and the traffic noise. Two big pools on both sides of the ecombiduct have been realized intended to stimulate the use of the passage and to attract bats such as Daubenton's bat which hunt for the insects on and above the water.

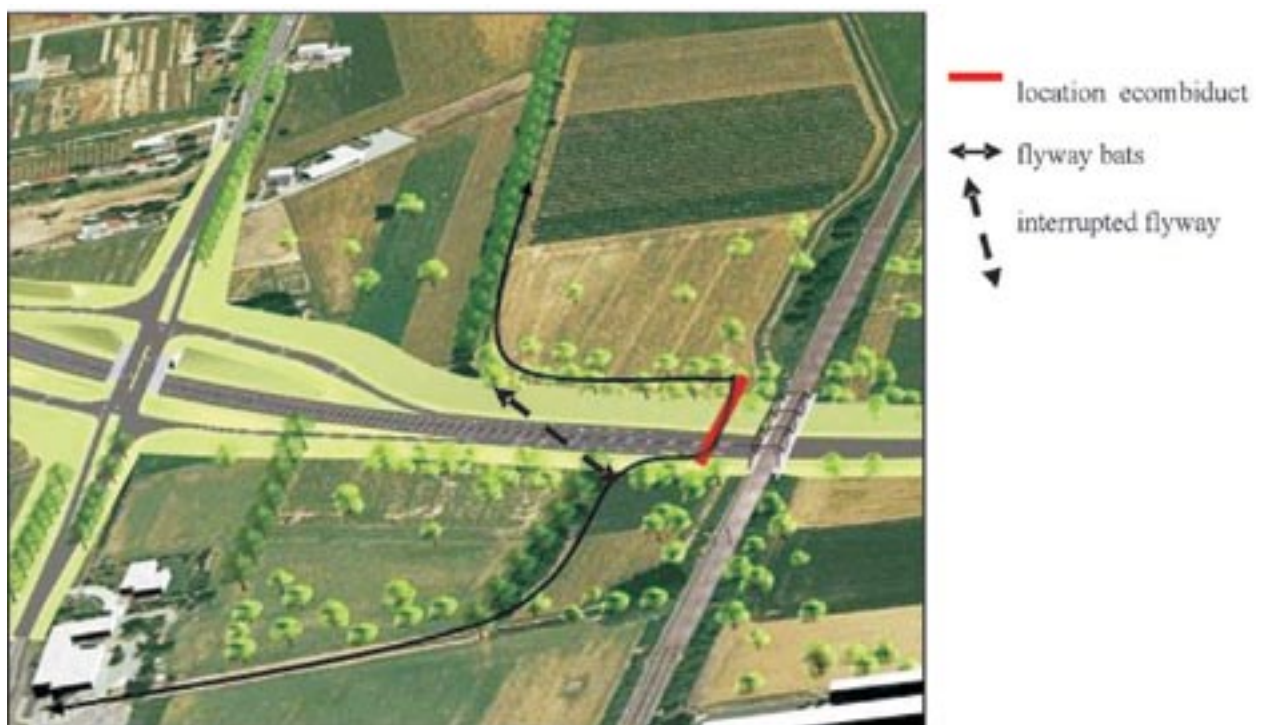
Fig. 7. The ecombiduct is situated on a former flyway of bats which is interrupted by the new road

With the project N297 a tree zone of 2.5 ha was planted as a compensation of the lost of ca. 4300m² hunting/forage area. With the construction of the N297, a bridge was heightened in a way that flyways of Daubenton's bat will not be disturbed. On a other interrupted flyway trees of 6 metre high were planted to restore this flyway. An exceptional mitigation measure which is implemented is the construction of a so-called ecombiduct (Fig. 6). This ecombiduct is situated on a former flyway of bats which is interrupted by the new road (Fig. 7).
